No.: ETR24704608

The following sample(s) was/were submitted and identified by the applicant as:							
Sample Submitted By		:	ESCORT SEAL CO., LTD.				
Sample Name		:	N6J01B				
Material No.		:	N7001B				
==================	=====	= = =					
Sample Receiving Date	9	:	21-Jul-2024				
Testing Period		:	21-Jul-2024 to 30-Jul-2024				
Test Requested	:		As specified by client, to test Asbestos in the submitted sample.				
Test Results	:		Please refer to following pages.

Test Part Description

No.1 : BLACK RUBBER

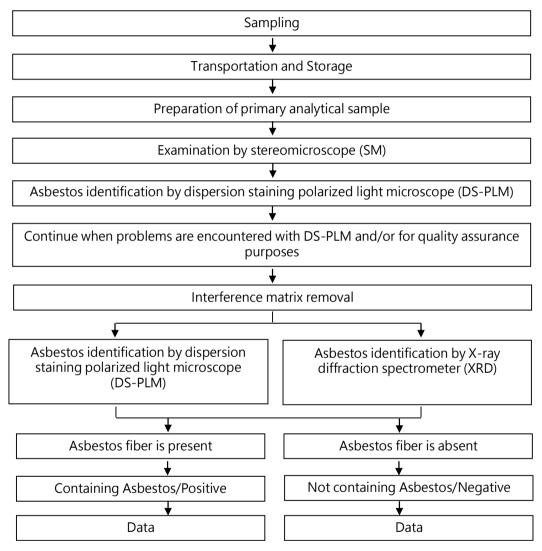
Analysis flow chart for determination of Asbestos [Reference method: EPA 600/R-93/116]

Test Item(s)	Method	Unit	Result
			No.1
Asbestos			
Actinolite (CAS No.: 77536-66-4)	With reference to EDA COO/D 02/11C. 1002	-	Negative
Amosite (CAS No.: 12172-73-5)	With reference to EPA 600/R-93/116: 1993, analysis was performed by Stereo Microscope (SM), Dispersion Staining Polarized Light Microscope (DS-PLM) and X-ray Diffraction Spectrometer (XRD).	-	Negative
Anthophyllite (CAS No.: 77536-67-5)		-	Negative
Chrysotile (CAS No.: 12001-29-5)		-	Negative
Crocidolite (CAS No.: 12001-28-4)		-	Negative
Tremolite (CAS No.: 77536-68-6)		_	Negative

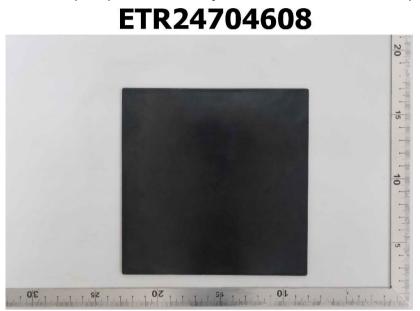
* The tested sample / part is marked by an arrow if it's shown on the photo. *
