Test Report

No.: ETR22C00459

ESCORT SEAL CO., LTD.

Test Requested : As specified by client, to test Halogen-Fluorine, Chlorine, Bromine, Iodine in the submitted sample.

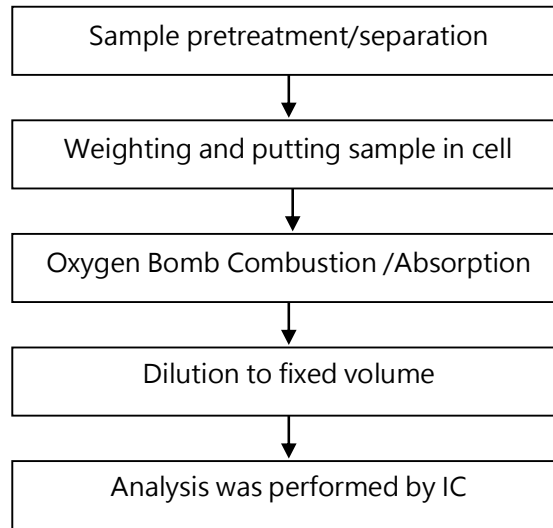
Analytical flow chart of Halogen

Test Item(s)	Method	Unit	MDL	Result
				No.1
Fluorine (F) (CAS No.: 14762-94-8)	With reference to BS EN 14582: 2016, analysis was performed by IC.	mg/kg	50	n.d.
Chlorine (Cl) (CAS No.: 22537-15-1)	With reference to BS EN 14582: 2016, analysis was performed by IC.	mg/kg	50	92300
Bromine (Br) (CAS No.: 10097-32-2)	With reference to BS EN 14582: 2016, analysis was performed by IC.	mg/kg	50	n.d.
Iodine (I) (CAS No.: 14362-44-8)	With reference to BS EN 14582: 2016, analysis was performed by IC.	mg/kg	50	n.d.

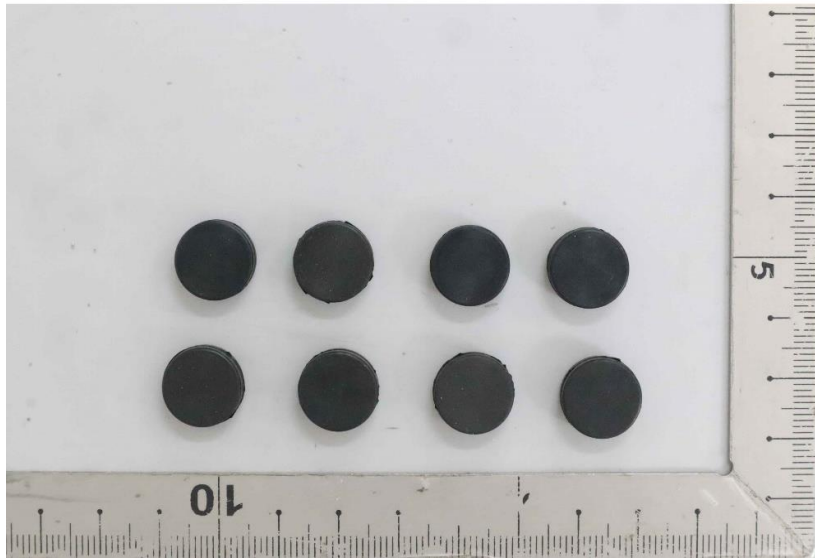
ETR22C00459

* The tested sample / part is marked by an arrow if it's shown on the photo. *
