# Test Report

No.: ETR22A01802

Sample Name : N6J01B

Test Requested : As specified by client, to test Asbestos in the submitted sample.

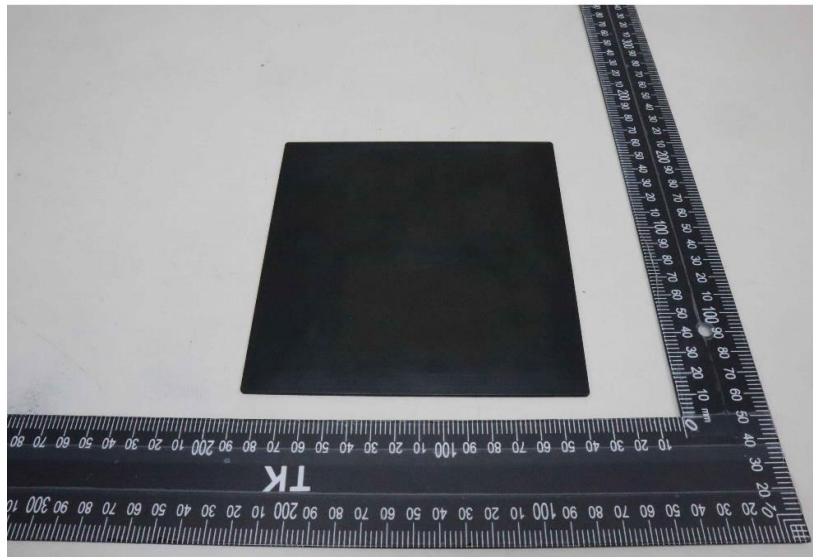
### ETR22A01802

\* The tested sample / part is marked by an arrow if it's shown on the photo. \*

No.1 : BLACK RUBBER
